RI 9366

REPORT OF INVESTIGATIONS/1991

## Entry Stabilization Utilizing Rib Bolting Procedures

By Dennis R. Dolinar and Stephen C. Tadolini

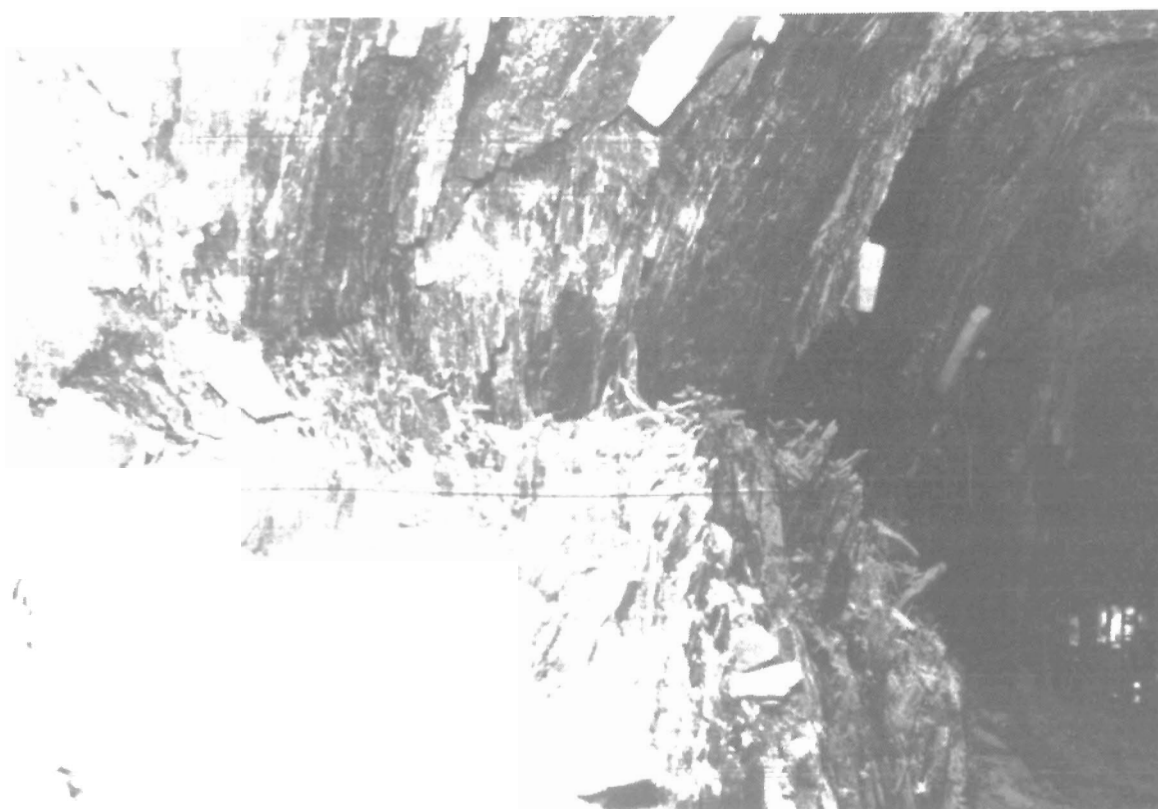
Figure 8.—Rib spalling and bolting along zone C of pillar.

**Zone C** - The failure of this rib occurs along the cleat where buckling is the primary mode of failure. The failure progresses perpendicular to the cleat, but the depth is

limited by the amount of exposed cleat. Thin slabs, 1 to 2 ft wide, will form along the exposed cleat. Several progressive failures may be observed along the rib; however, more spalling occurs near the zone B corners. A parting along the rib also enhances the buckling of the slabs. Figure 8 shows the zone C rib failure.

In zone C, there was general failure of the rib below the line of support because of buckling of slabs. To minimize the height of the slabs, at least one more row of supports could be added. Along the line of support, the rib is held in place around the bolts, but spalling between the bolts occurs as a sufficient width of slab along the cleat is exposed and as failure of the lower portion of the rib extends upward. Because of the failure mechanism and the cleat direction, the width of material formed along the rib or line of support is small. Either a tighter bolt spacing or the use of pans or straps is required, therefore, to maintain more of the material. For the corner (zone B) and rib (zone C) where buckling occurs, the failure mechanism will probably be altered with the proper application of support. The maximum loads these zones are able to withstand will probably increase. Since these are high stress zones, however, yielding or failure may still occur, especially as extension takes place across the cleat. When buckling occurs, the support pattern has to reflect the minimum height and width of a slab that could buckle. These minimum dimensions could be considered as the size and geometry of a spalled piece of rib or rib that could spall.
